MEMORANDUM

State of Alaska Department of Fish and Game Division of Habitat

SUBJECT: Kanalku Falls Blasting
8/26-28/2013 Trip Report

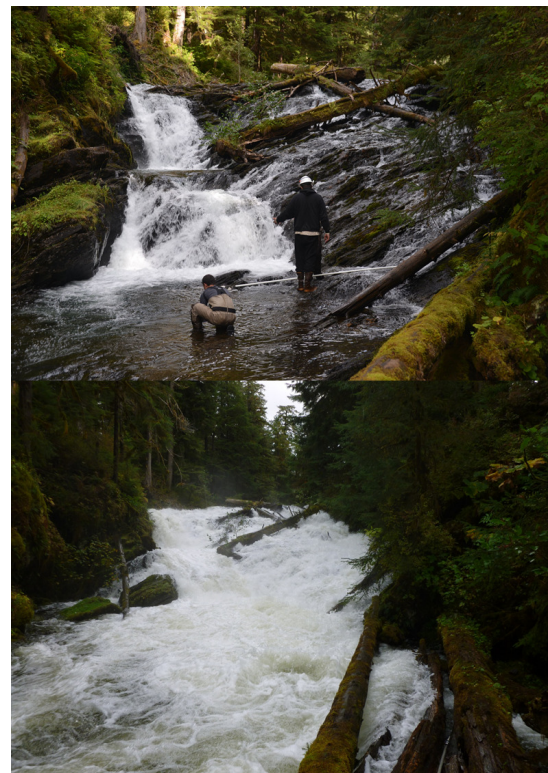
Figure 1 Kanalku Falls under low (August 26th, 2013) and high (September 23rd, 2013) flows. (Photos: Kristen Kolden and Pete Schneider)

On August 26th through the 28th, 2013, I traveled to Kanalku Lake to assist with a Division of Commercial Fisheries (Commfish) project to improve fish passage over Kanalku Falls (ADF&G Stream No. 112-67-10600; chum, pink, sockeye, and Dolly Varden char present; Fig 1). Commfish contracted with the USFS to conduct the work due to USFS expertise in fish and blasting. Habitat permitted the project and hired Alaska Seismic & Environmental to monitor vibrations in accordance with the Alaska Blasting Standard for the Protection of Fish (Timothy 2013) when fish are in the area during blasting.

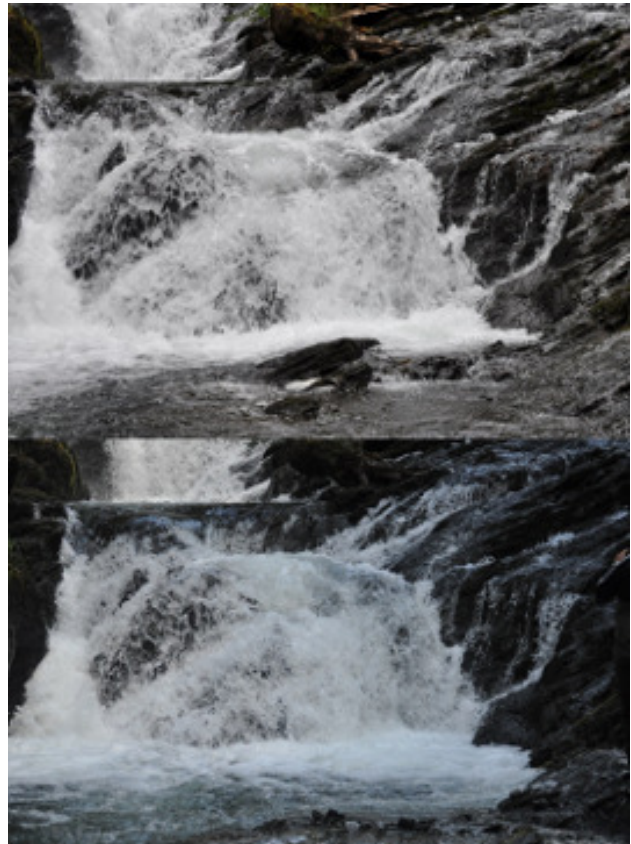
Figure 2. Kanalku Falls before (top) and after (bottom) the blast (Photos: Randy Bates)

Low flow conditions allowed for the exposure of the bedrock for blast planning and drilling. Rob planned a drilling/shooting pattern that would keep overpressures as low as possible, while fracturing most of the rock into small pieces that would wash out during high flows and consulted with Kristen and Cathy on the matter. Drilling took 1.5 days with 3 drills running most of the time and the results of the shot were very close to what was expected. The jump pool was about 50% filled with blast debris immediately after the shot (Figs 2-4). Holes were drilled 5-6' below the water surface; however, the newly excavated hole filled with waste rock and depths varied between 1.4' and 3.2' under the low flow conditions. The jump pool maintained a 15' maximum depth at the upstream end and we determined that conditions were suitable for fish passage so mucking out waste rock would not be necessary. This task would have been overwhelming without heavy equipment. We expect most of the rock to clear out this year during high flows and will go back in the spring to document bathymetry. During drilling, the water was slightly milky downstream and the turbidity associated with the blast cleared within 25 minutes.

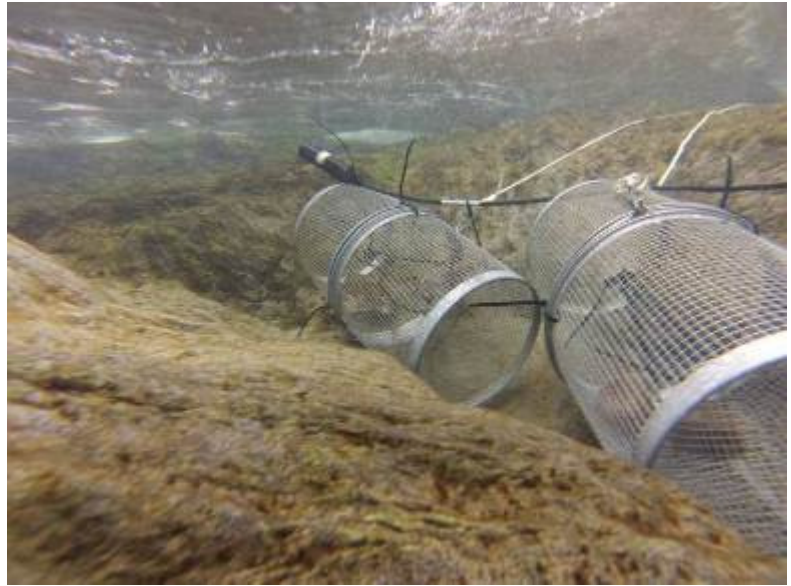
Figure 5. Sealed test cages in place with hydrophone ziptied on (Photo Kristen Kolden)

Overpressures from the shot attenuated quickly through the bedrock stream channel and hydrophones placed 15' and 42' feet from the blast center recorded overpressures of 6.63 and 1.33 PSI (Fig 5). A third hydrophone at 57' was malfunctioning and did not record the blast. Geophones placed on bedrock at 24', 43', and 61' recorded peak particle velocities (PPVs) of 0.73, 0.31, and 0.37 in/sec. A geophone placed in the gravel underwater at 49' recorded a PPV of 0.17 in/sec. (See attached Kolden, 2013)

We placed juvenile coho (55-75 mm) in 6 sealed Gee minnow traps to monitor their response at known overpressures. Each trap was sealed with zipties and contained a rock for weight and 5 fish (Fig 5). Test

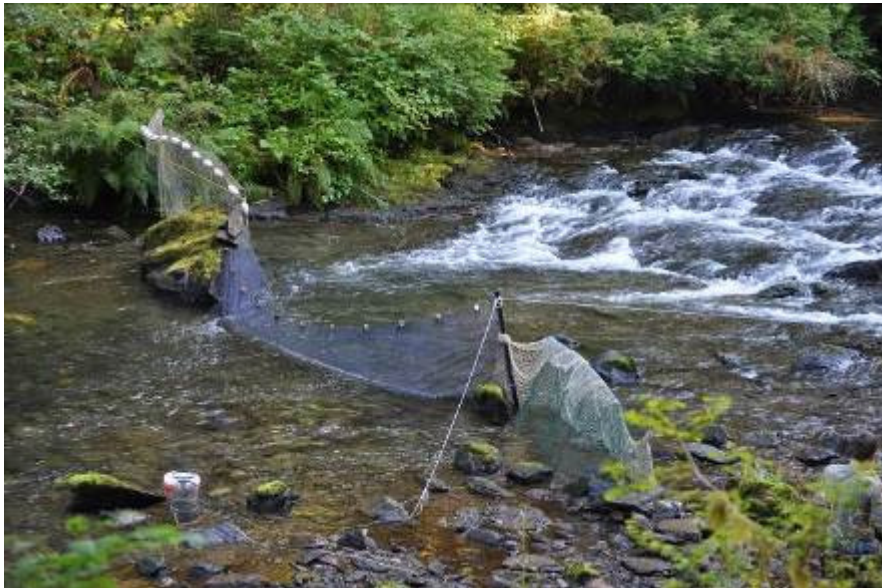
Figure 6. Weir constructed out of rigid and cloth mesh 185' downstream of the blast. (Photo: Randy Bates)

Matt and I constructed a weir out of materials brought from Juneau and those available on site to hold fish larger than ~180 mm 185' downstream of the blast center (Fig 6). Fish smaller than ~180 mm were held below the weir in perforated 5-gallon buckets. We used dip nets, a cast net, minnow traps and snagging gear to remove fish upstream of the weir (Fig 7). Minnow traps, cast and dip nets were extremely effective downstream of the jump pool and snagging rods provided by Commfish staff were used to remove most fish from the turbulent and deep jump pool. After snagging with a barbless hook, we quickly released fish into a net and transported downstream. We did not observe any snagging mortalities.

It was unfortunate that fish died during our depletion efforts, but we expect the long term benefits of increased escapement to outweigh the short term effects and know that the data gathered will have long term value. The weir was constructed in a conservative location 185' downstream, which resulted in a large area for fish removal. Had the weir been positioned closer, fewer fish would have had to have been removed and handled.

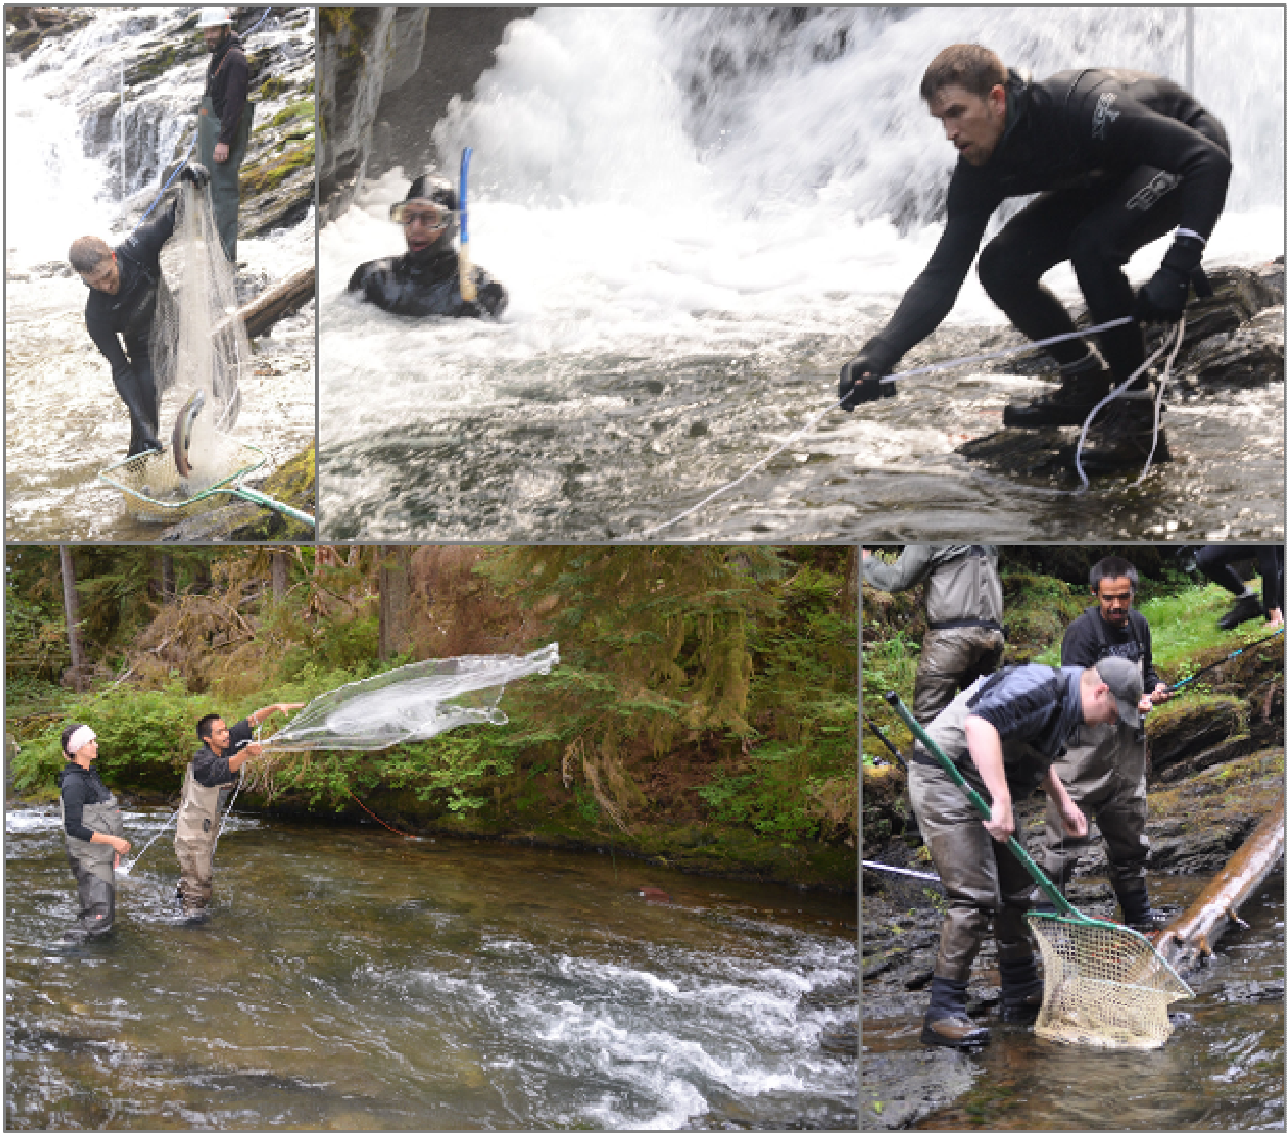
Figure 7. Almost every member of the crew assisted in removing fish from the area. Top left: Greg transfers netted pink salmon into a dipnet for transport. Top right: Greg pursues the cast net on fish herded into the area by Matt. Bottom left: Kristen instructs Ben while he makes an excellent throw on his first ever cast net attempt. Bottom right: Ray lands a pink salmon in the cast net for quick transport downstream. (Photos: Kristen and Randy)

On the day of the blast, Matt and I arrived early to find that about 30 salmon had jumped the weir and needed to be removed from the blast area. With drilling operations complete, we were able to safely and effectively snorkel the jump pool (turbidity was high and conditions more dangerous during drilling) and remove all but about 29 of the remaining fish. To accomplish this, Matt would snorkel to the bottom of the jump pool and scare the fish to where I could cast net them while he prevented them from diving down again (Fig 7). We had placed 6 minnow and barrel traps in the jump pool overnight; however, they caught few fish in this area.

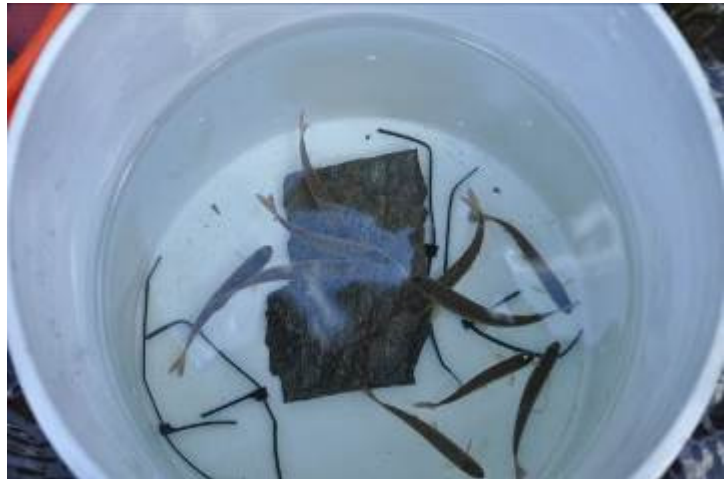
Figure 8. Test fish were monitored for 3 hours after the blast then released.

fish were caught and held in minnow traps <16 hours before the blast. We secured two traps each at the 42' and 57' hydrophone stations located in pools with slow current and two behind the weir to serve as experimental controls. The 15' hydrophone station was in high velocity water and was not suitable for holding fish in cages and no other low velocity location was available at this range. We observed the 30 test and control fish in perforated buckets for 3 hours after the blast and saw no signs of injury or mortality (Fig 8). Eighteen injured or dead fish were recovered after the blast in the jump pool and downstream to the weir. We found one adult pink salmon twitching with rapid eye movements about 50' downstream of the blast and released it after its condition improved. We found two adult pinks, 1 adult sockeye and 1 Dolly Varden dead in the bottom of the jump pool along with 10 live fish, the rest of the fish mortalities were either washed up on the weir or found in the stream (Table 1; Fig 9).

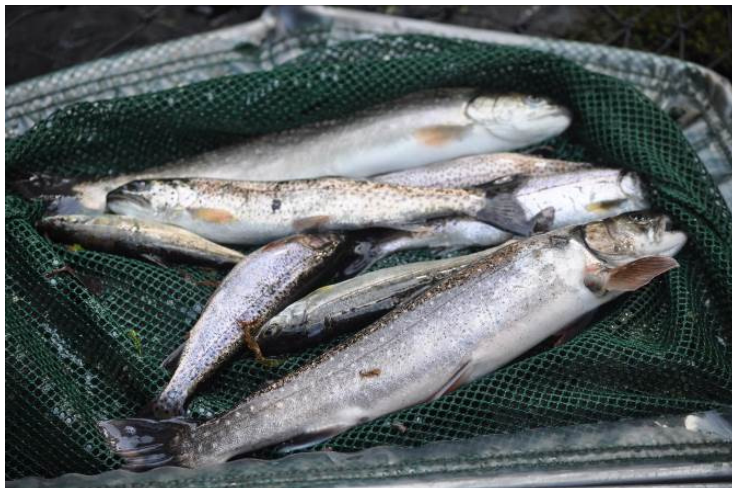
Figure 10. Dolly Varden, cutthroat trout and juvenile coho were among the 18 mortalities found after the blast. (Photo: Randy Bates)

We necropsied the large mortalities and found most fish had internal organ ruptures; kidney and spleen ruptures were easily identified (Fig 10). Overpressure data and our observation of identifiable fish (Fig 4) holding in the bottom of the jump pool before and after the blast suggest mortalities occurred within about 5-10' of the explosion.

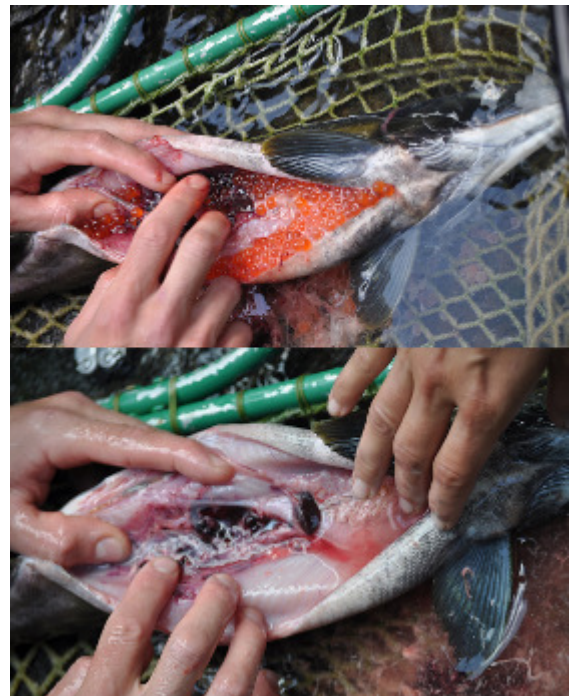
Figure 9. Adult pink salmon mortality with a ruptured kidney. (Photo: Randy Bates)
